## TEST REPORT: P07104-T03

**Test order no.:** P07104

**Name of the test order:** Practical testing and water leak testing of the  
Circum-MINI interior pipe sleeve  
Testing the high pressure flushing stability per  
procedure 2 of DIN 19523 and leak testing per DIN  
EN 1610

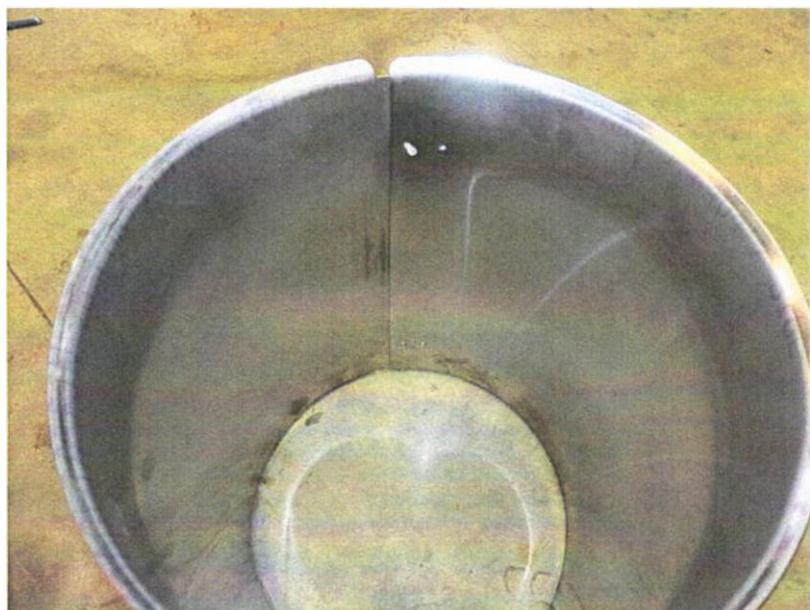
Figure 1: Interior pipe sleeve Circum-MINI DN 300

The Circum-MINI comprises an EPDM seal and a stainless steel sleeve with an external closure. Clamping the stainless steel sleeve by means of a packer presses the EPDM seal to the pipe's interior wall, so that the sealing lips at the ends seal the sleeves to the sewer in accord with the principle of compression sealing. Retightening the sleeve is possible at any time.

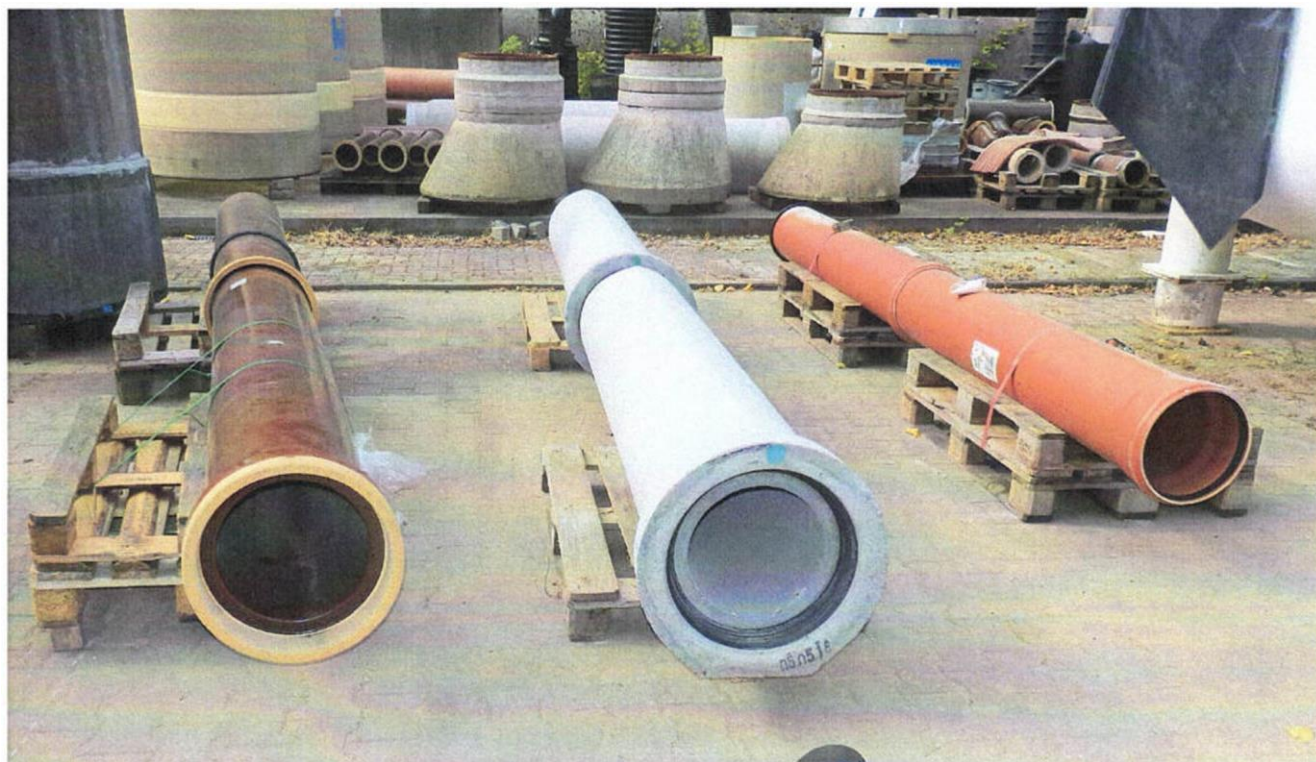
Figure 2: Test segment 1 (stoneware-stoneware), test segment 2 (concrete-concrete) and test segment 3 (PVC-PVC) DN 300

The basis for the high pressure flush trial is DIN 19523, procedure 2 – practical testing, in which the requirements of the high pressure flush stability of pipe materials are defined. For practical testing, the following three trial segments of nominal width DN 300 are set up (see Figure 2):

- Trial segment 1: Stoneware-stoneware, entire length 5 m
- Trial segment 2: Concrete-concrete, entire length 5 m
- Trial segment 3: PVC-PVC, entire length 4 m

Before setting-up the trial segments, leaks were created in the pipe connections of these segments through the partial or complete removal of seals. The installation of the Circum-MINI over the pipe connections then resealed these again.

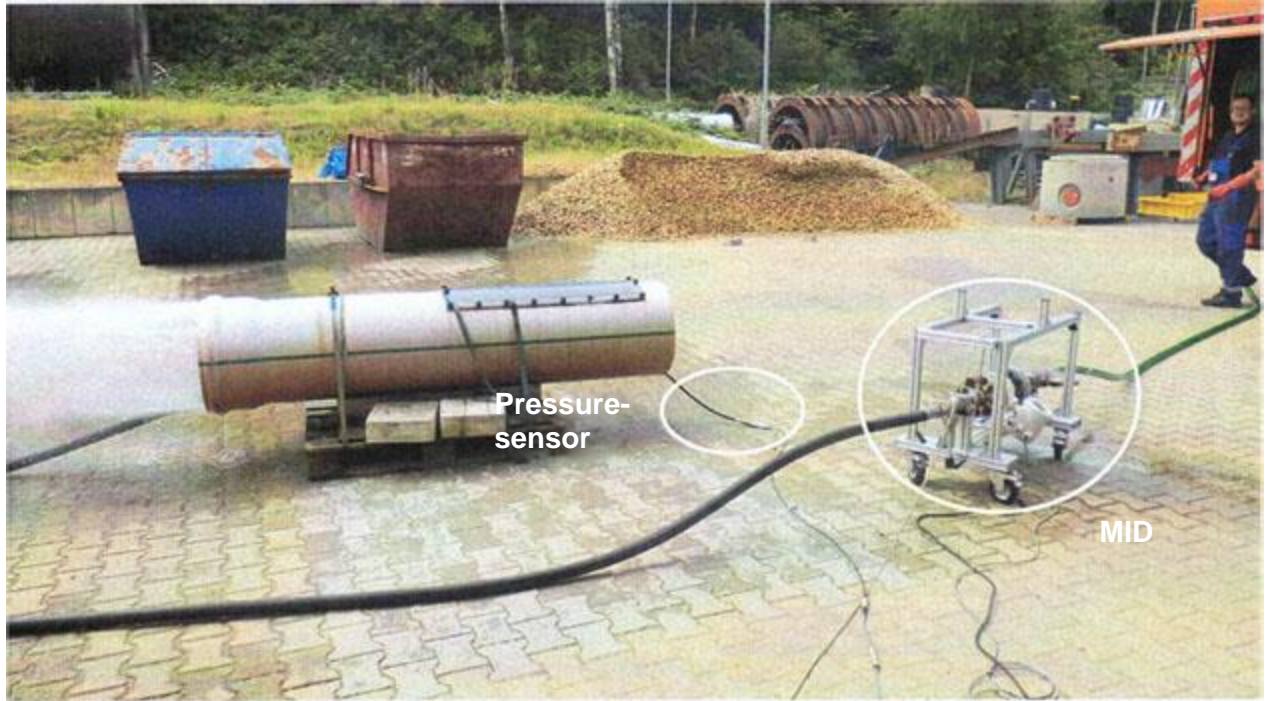
Figure 4: Monitoring the test parameters

Before the start and after concluding the testing, the pressure is determined not farther than 0.1 meter from the nozzle body at a volume flow of between 280 l/min and 285 l/min by using a pressure sensor (see Figure 4). The volume flow is determined by using a magnetic inductive flow-through measuring system (MID). During the testing the pressure is then monitored via the manometer on the vehicle.

Before the testing	After the testing
Pressure at the nozzle [bar]	118	117
Volume flow [l/min]	283.2	280.4
Flush blast sealing capacity $D_j$ [W/mm <sup>2</sup> ]	342	332
$C_d$ -value	0.723	0.717
Metrology display

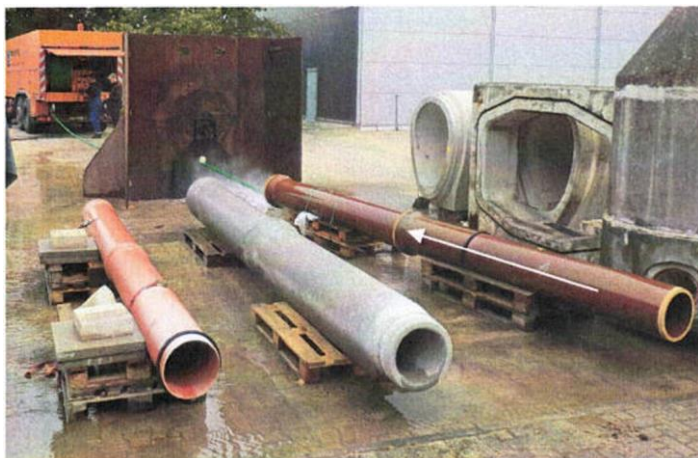
Figure 5: Trial implementation test segment 1 (direction of flush in the direction of the arrow)

After determining the test parameters, the trial segment is stressed by 60 cleaning cycles (see Figure 5 to Figure 8). Following that, the sleeves are visually inspected.

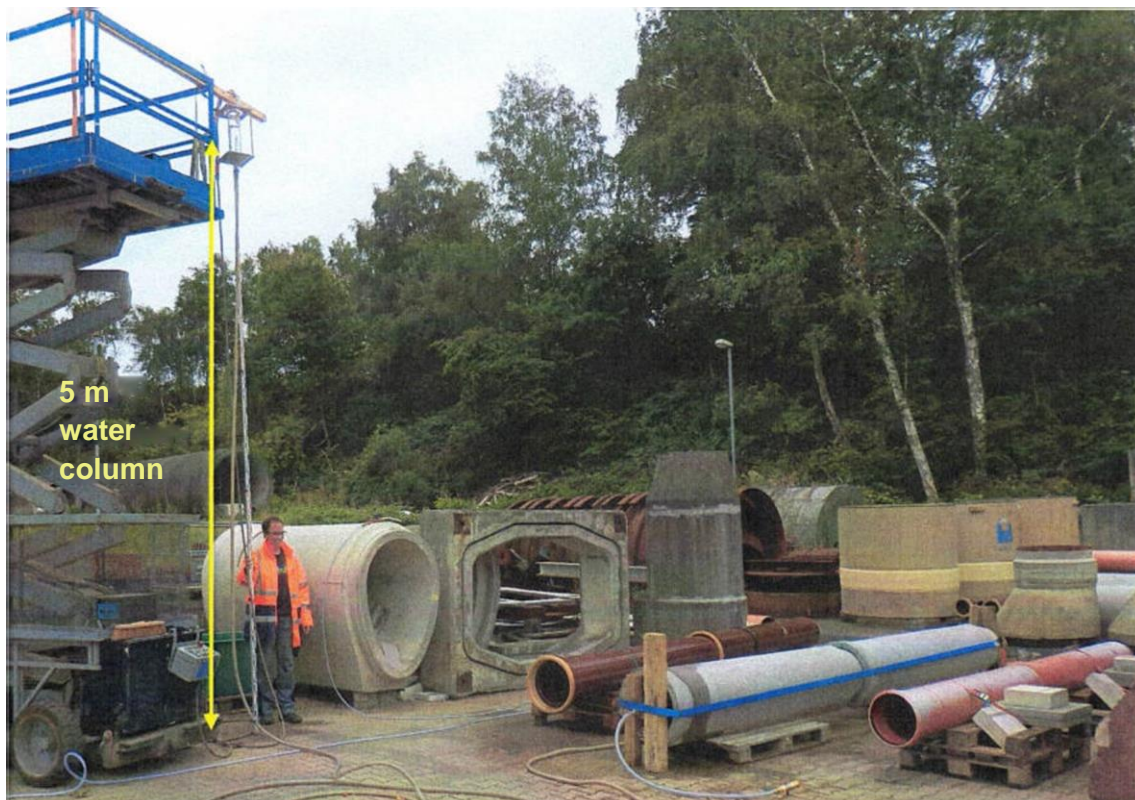
Securing straps helped prevent the sealing bubble from squeezing out and the individual pipes from sliding apart. (see Figure 9 and Figure 10).

Figure 9: Test setup for the leakage test at 0.5 bar (5 m water column)

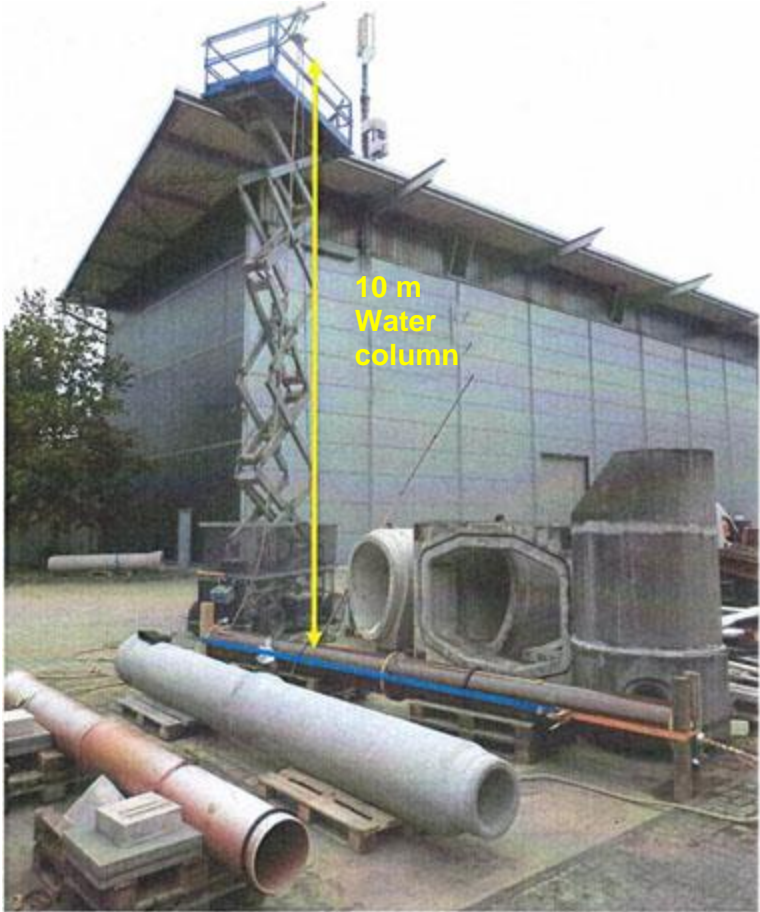
Differing from DIN EN 1610, according to which an addition of water of 0.15 l per m<sup>2</sup> of wetted pipe wall is permissible for the holding leakage test on the construction site in a test time of 30 minutes, a visual check of the test specimen took place here to evaluate the water tightness. Visible leakage of water means the test has not been passed. The interior sleeve must seal the pipe connections during the leakage testing with a test pressure of 0.5 bar for a period of 30 minutes. The test pressure of 0.5 bar is set with a 5 m high water column over the apex of the pipe (see Figure 9). Moreover, the seal of the Circum-MINI in all trial segments and in each load condition was additionally tested with a water internal pressure of 1.0 bar for 30 minutes following the testing of the high pressure flush stability in all trial segments. This test pressure was implemented with a 10 m high water column over the apex of the pipe (see Figure 10).

Figure 10: Test setup for the leakage test with 0.1 bar (10 m water column)

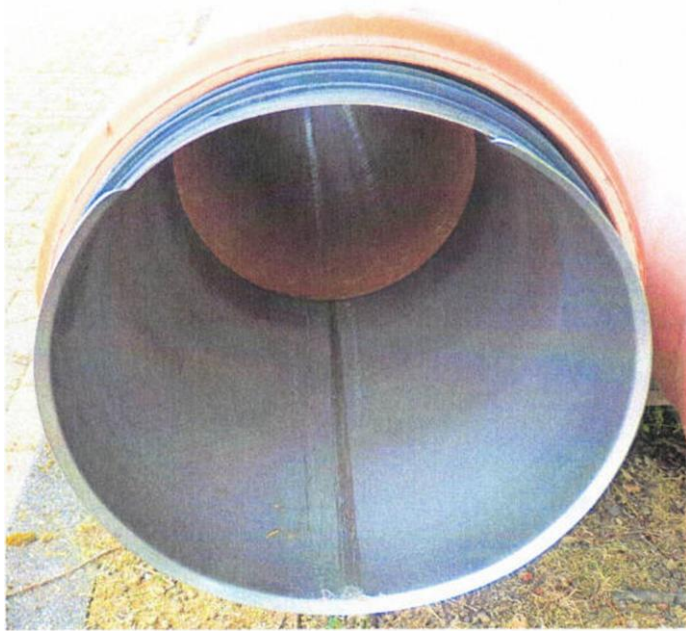
Figure 11: Circum-MINI (interior pipe collar DN 300 after 60 cycles)

After the stress of 60 cleaning cycles with a flushing blast sealing capacity between  $332 \text{ W/mm}^2$  and  $342 \text{ W/mm}^2$  and a volume flow between  $280.4 \text{ l/min}$  and  $283.2 \text{ l/min}$ , the investigated sleeves for all of the trial segments showed no damage. The stainless steel sleeves show only scratch marks in the base area (Figure 11).
